Emerging threats and competing land use types, the balance between development and conservation; a case of the Tsavo ecosystem

Cpt. Robert Obrein
AD- Tsavo Conservation Area

Infrastructure Developments in TCA:

Construction of Standard Gauge Railway (SGR)

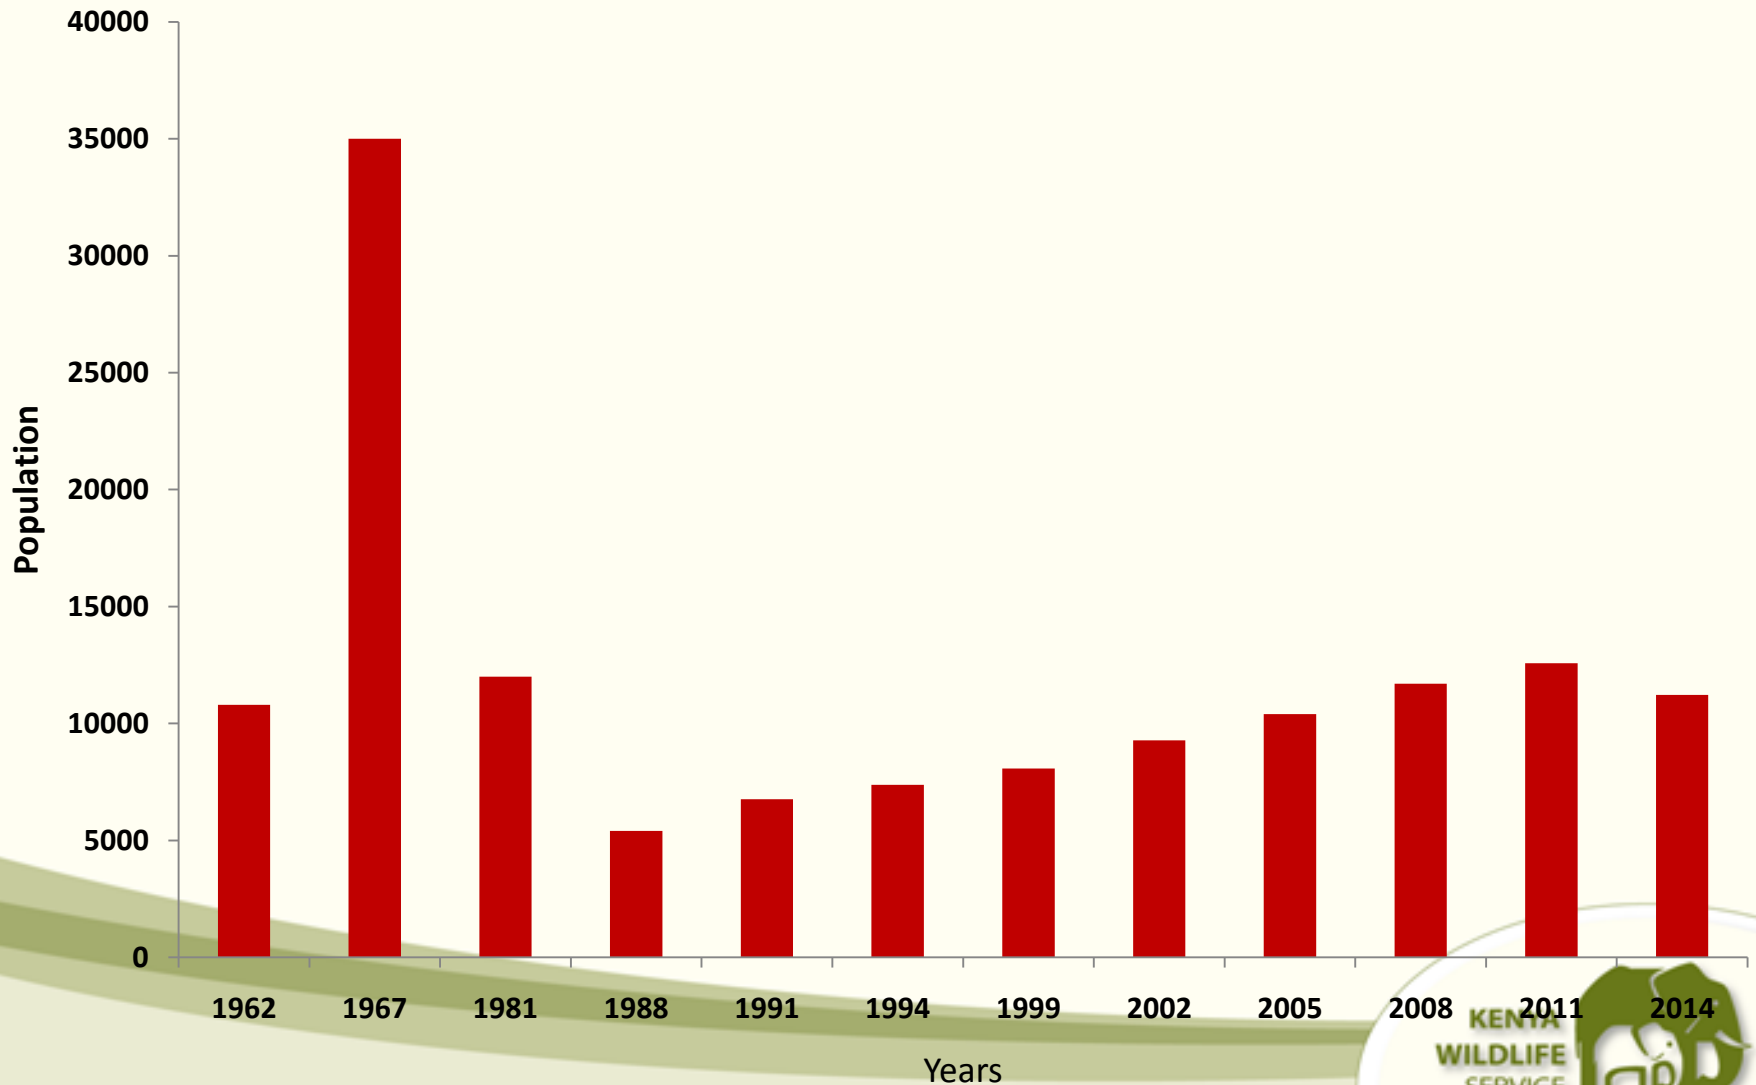
Tsavo Conservation Area: Elephant numbers from the year 1962 to 2014

- The population of elephants continued to increase in TCA as follows:
- 1994 the population was 7,371
- 1999 the population was 8,068
- 2002 the population was 9,284
- 2005 the population was 10,397
- 2008 the population was 11,696
- 2011 the population was 12,573

- Aerial census conducted in the year 2014 resulted to decrease in elephant population to around 11,217 however a sample count Conducted the same year indicated that the population of elephants was between 12,000- 14,0000
- Next census is scheduled in March 2017

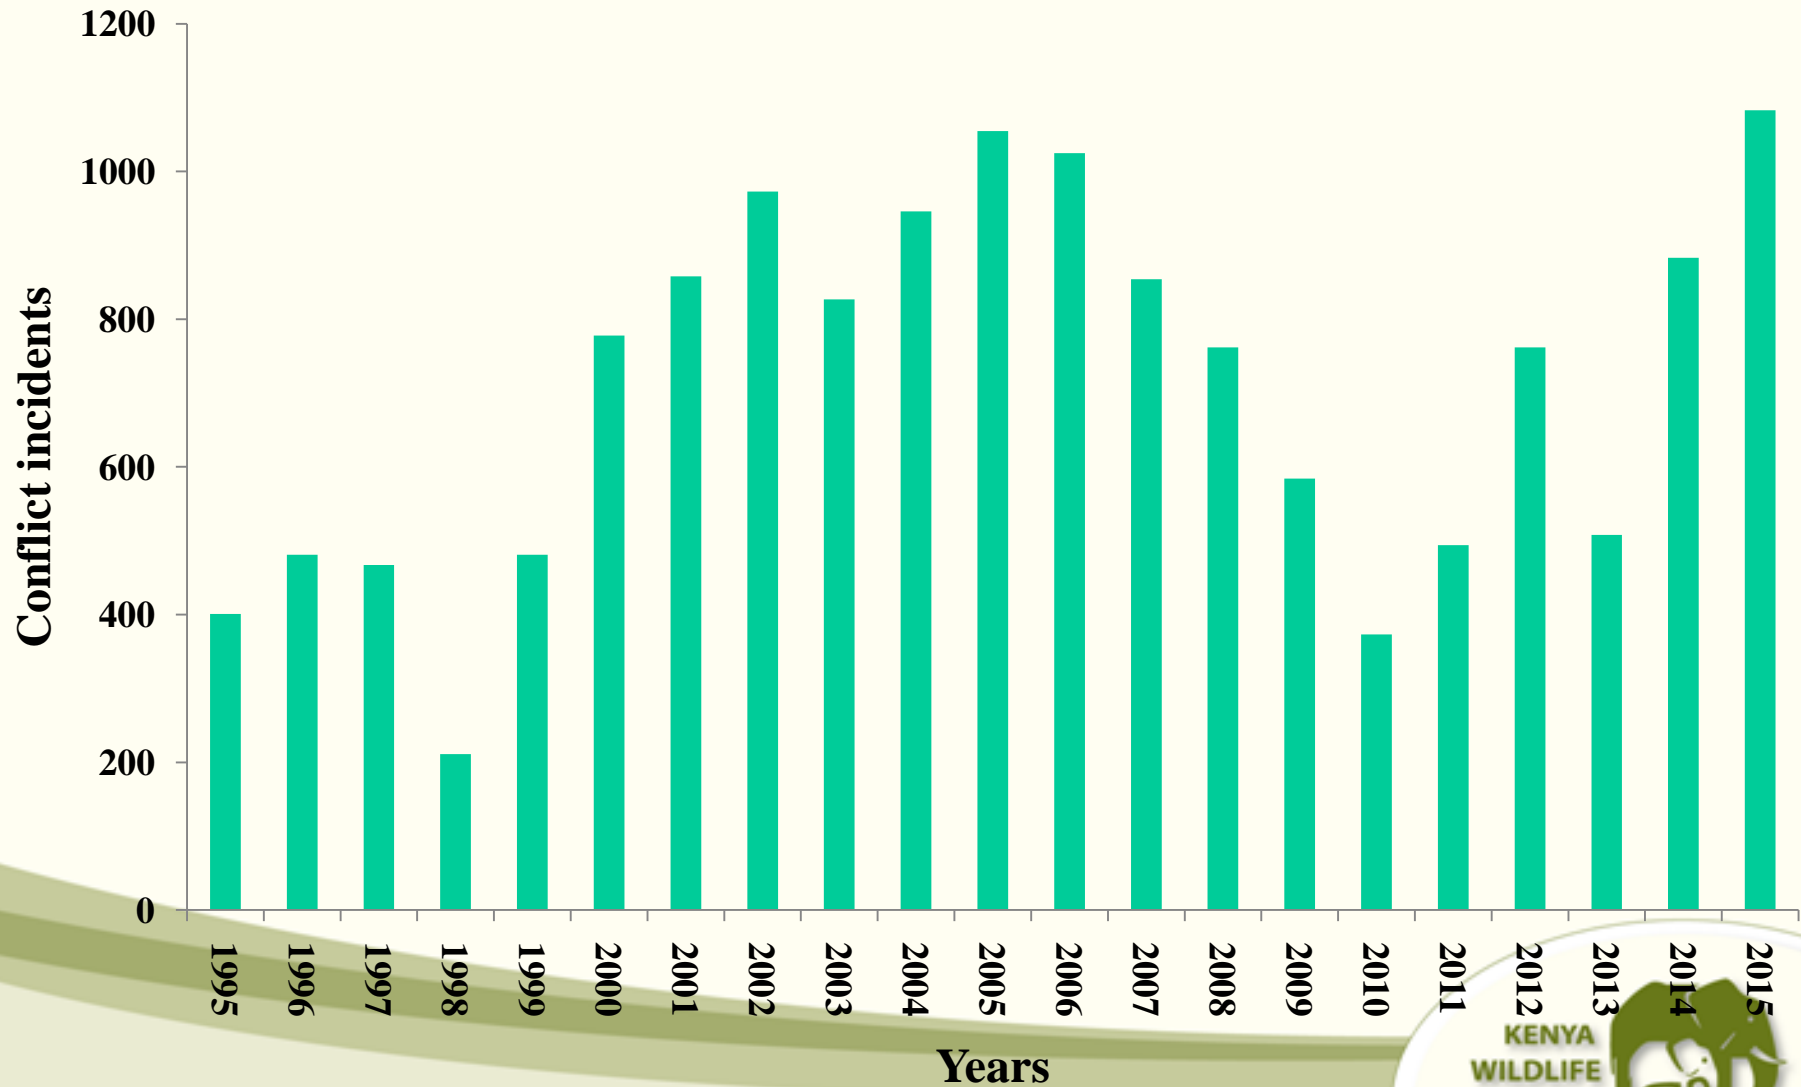
HEC trends in TCA 1995 to 2015

- Human elephant conflict continued to escalate in TCA until the year 1992 when KWS formed problem control unit to deal with human elephant conflict.
- Major human elephant conflicts in TCA include the following:
 - Crop damage
 - Property damage
 - Human threat , injury and death
 - Elephant death and injury

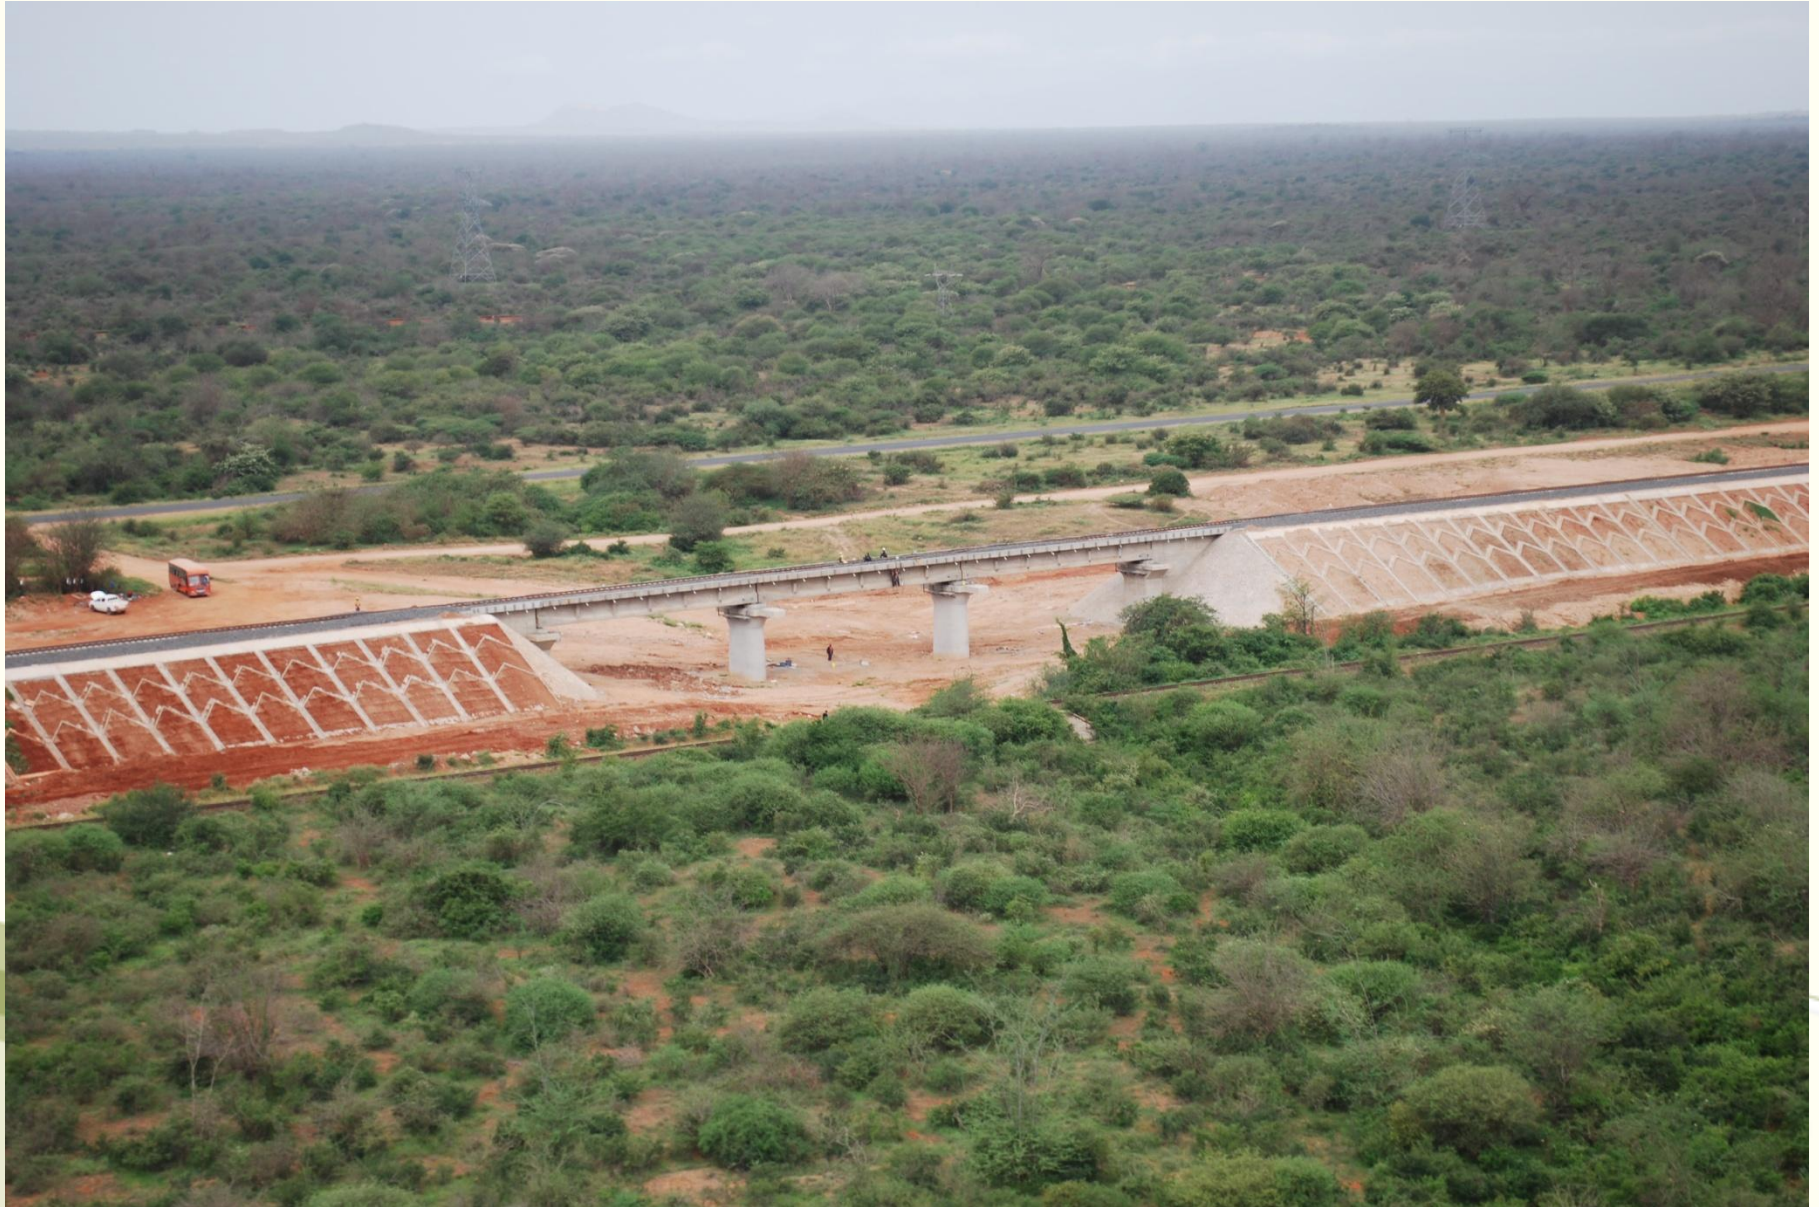
Wildlife corridor in Kenani

- To allow movement of wildlife in their dispersal and migratory regions, wildlife corridors were mapped.
- Six corridor have been constructed in Bachuma, Maungu, Ndara, Manyani, Kenani and Kanga.
- Apart from the six, wildlife will also use the Tsavo bridge as the corridor.

- Culverts have been constructed for the purpose of water but some are big enough to serve as wildlife crossings.
- Construction of these corridors are underway and almost complete.

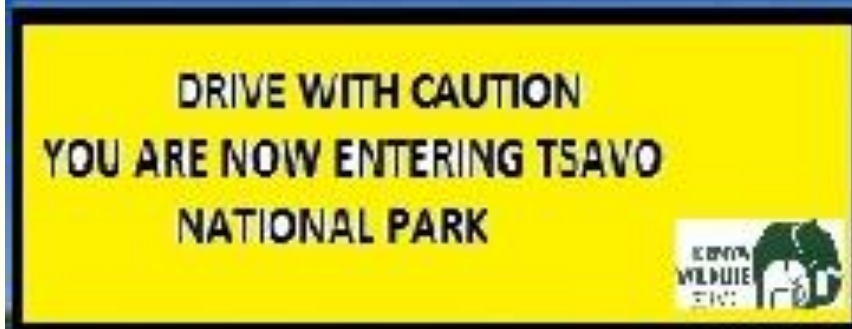
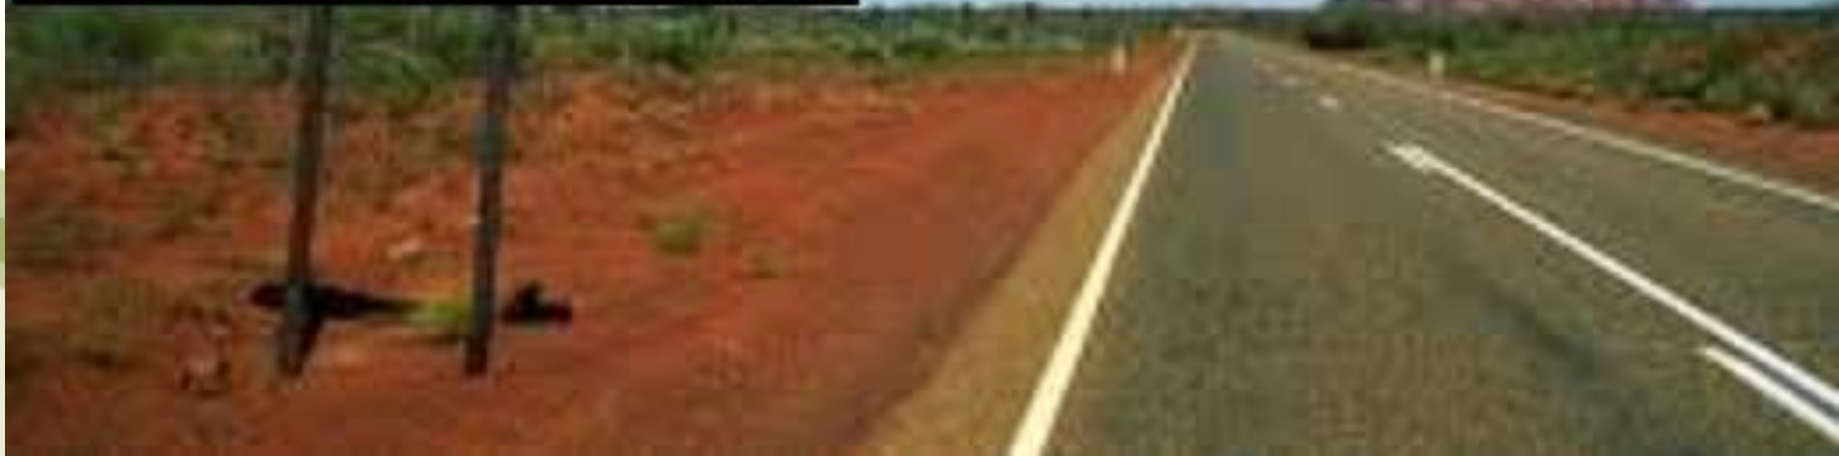
AN EXAMPLE OF ROAD SIGNAGES TO BE ERECTED ON THE HIGHWAY

- Ten elephants have been fitted with satellite linked GPS collars along SGR from Bachuma to Mtito Andei to assess how elephants utilize the corridors and culverts.
- Camera traps will be fitted in the wildlife corridors to monitor utilization of corridors and culverts by wildlife.
- Road sign ages and bumps will be erected on the highway to warn motorists when arriving at wildlife corridors.

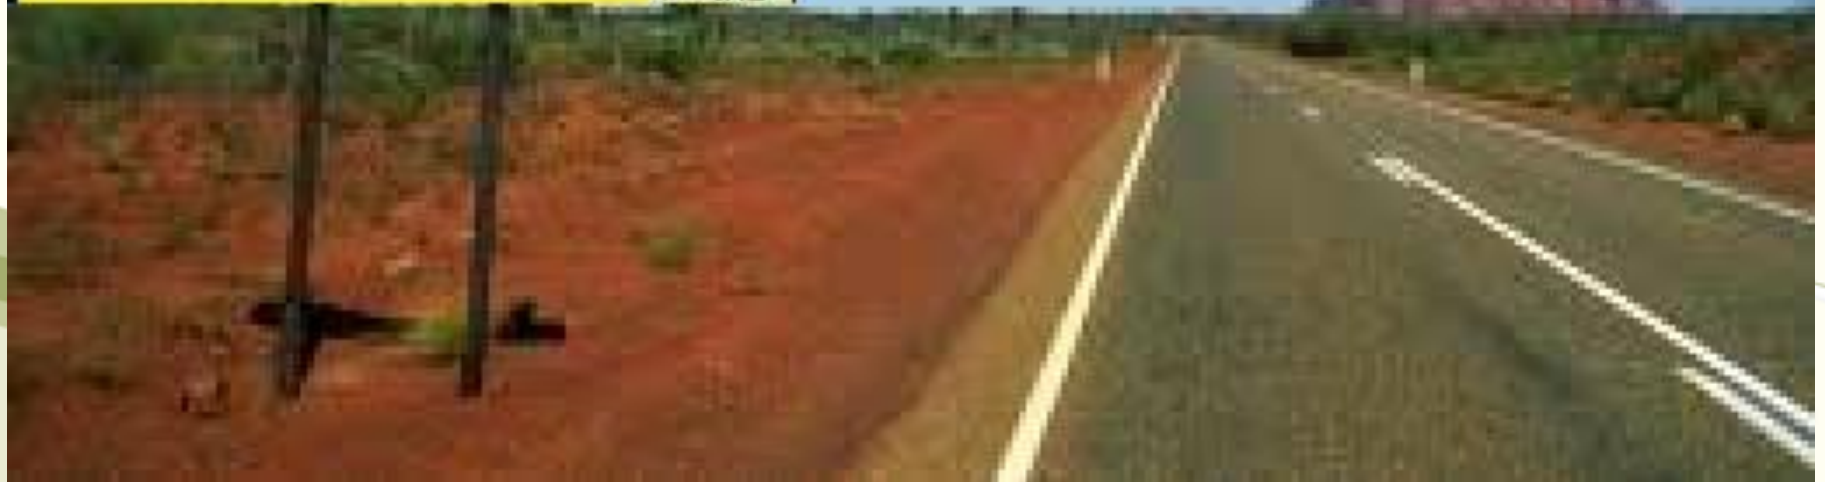
EXAMPLE OF ROAD SIGNAGES TO BE ERECTED ON THE HIGHWAY

BEWARE OF WILDLIFE CROSSINGS
DO NOT LITTER, DO NOT STOP
DO NOT FEED THE ANIMALS

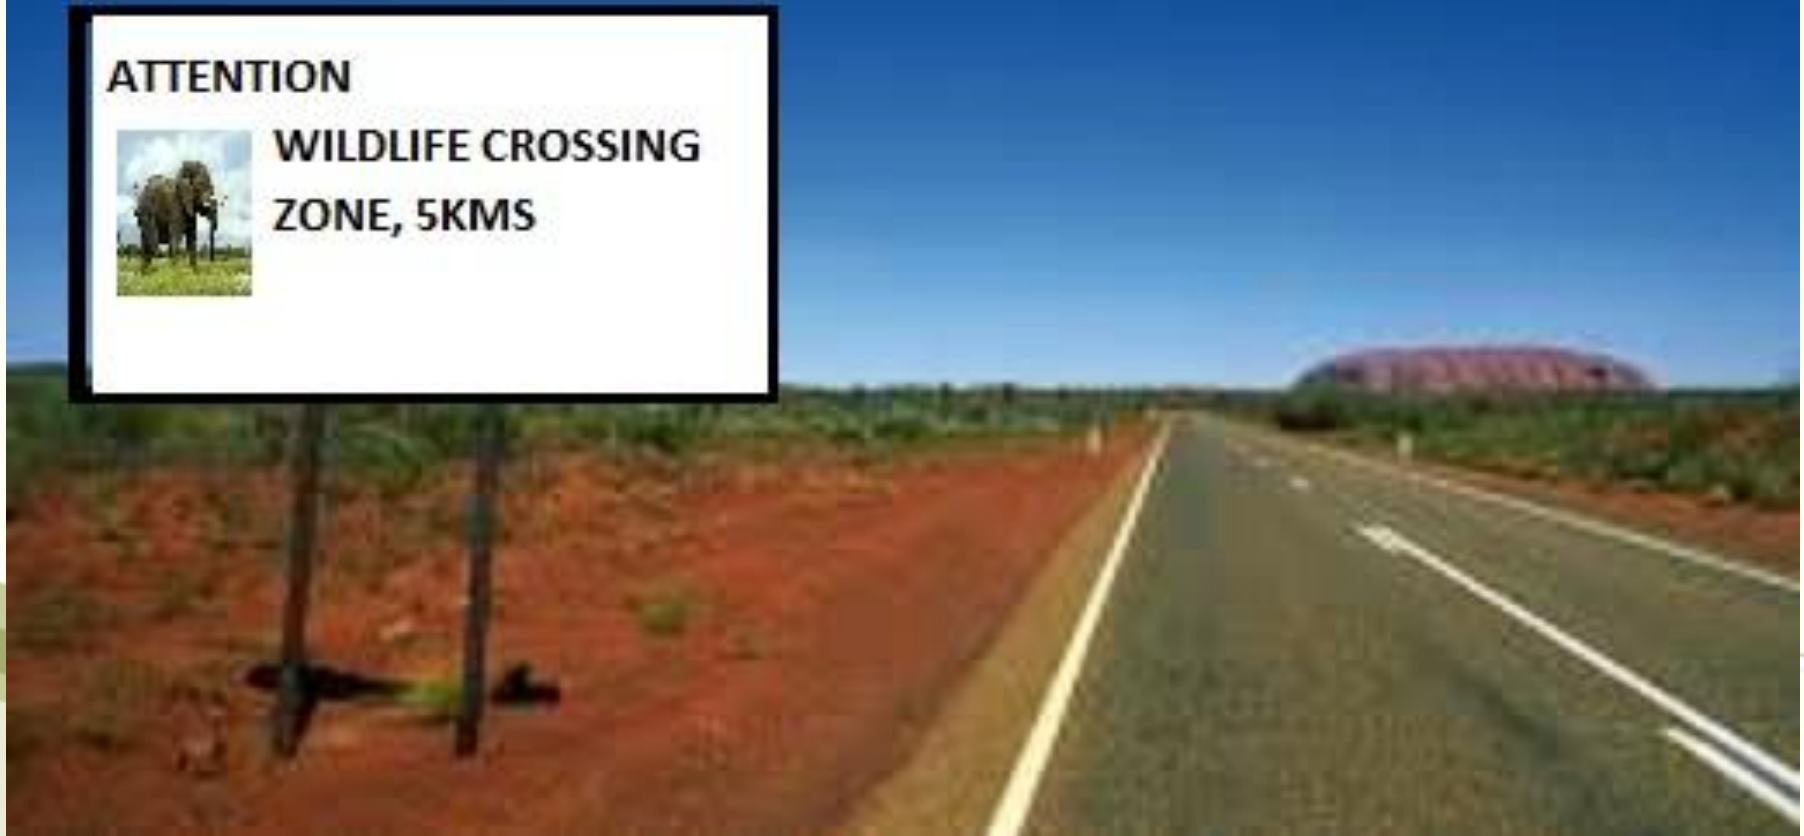
AN EXAMPLE OF ROAD SIGNAGES TO BE ERECTED ON THE HIGHWAY

**WILDLIFE CROSSING
ZONE, 5KMS**

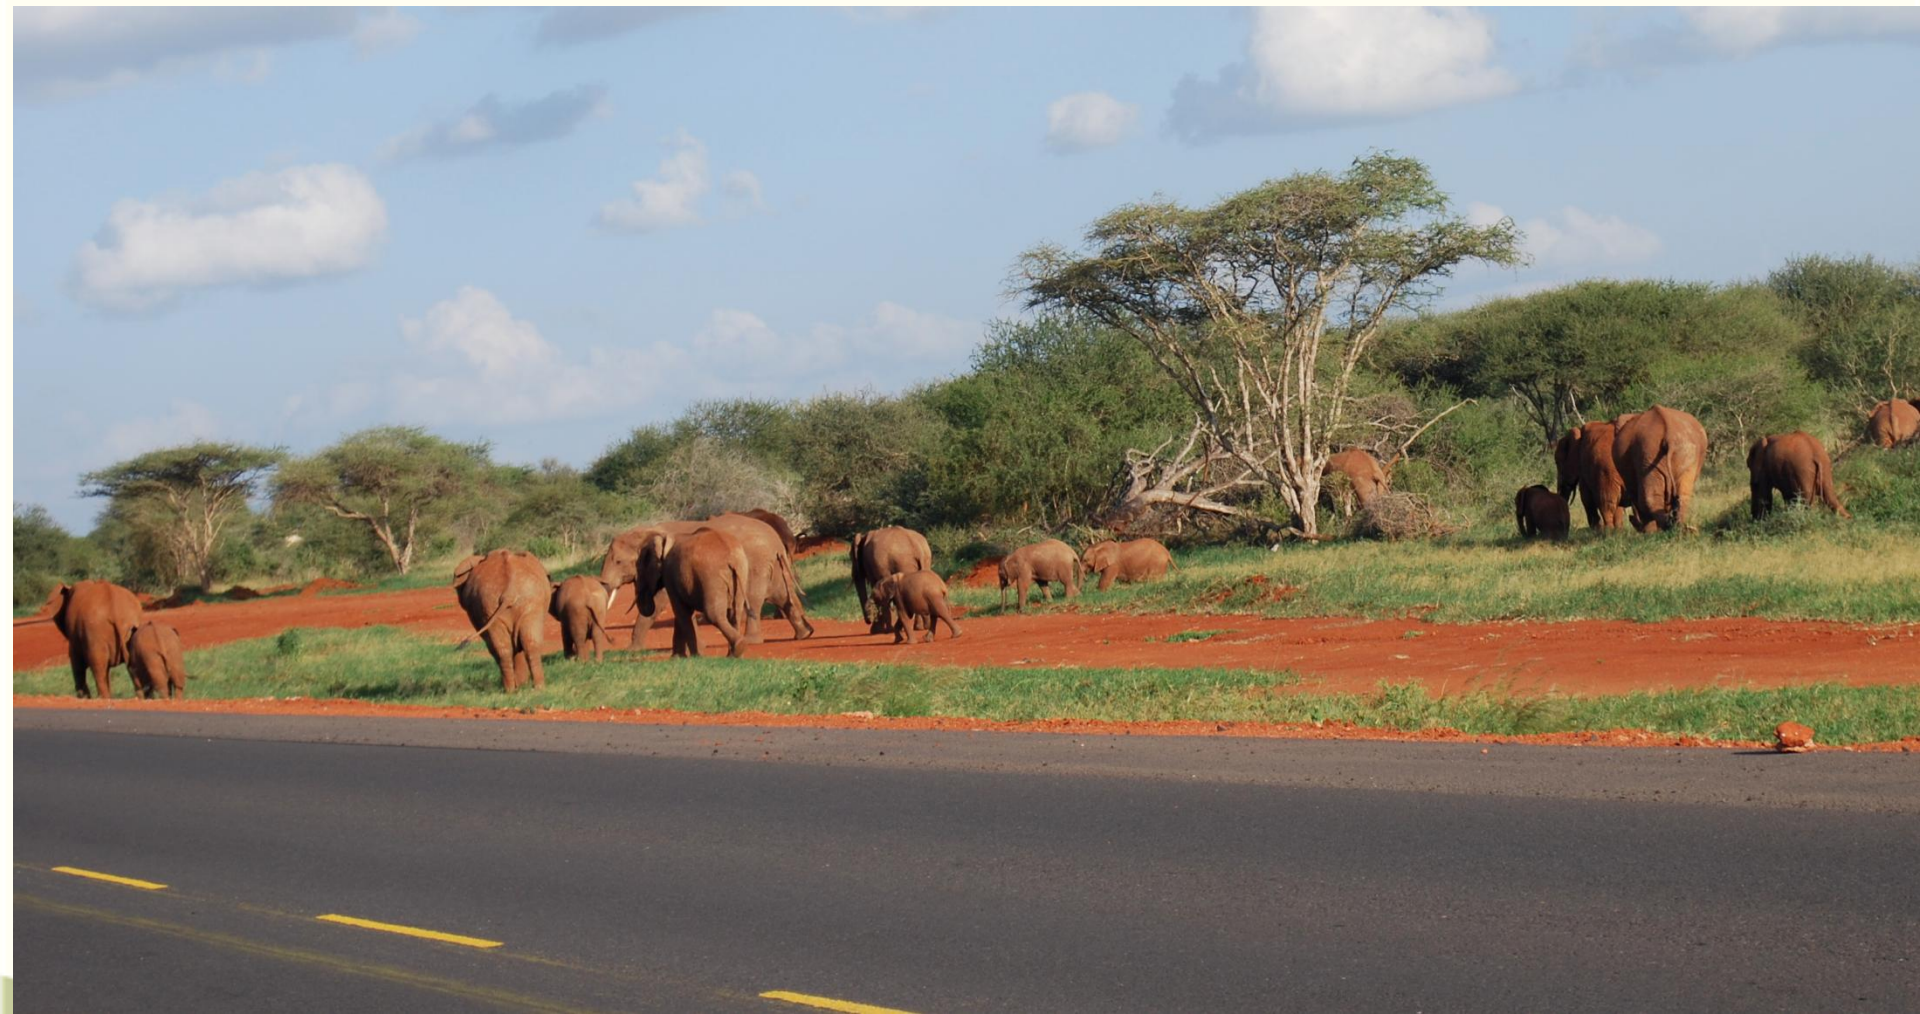
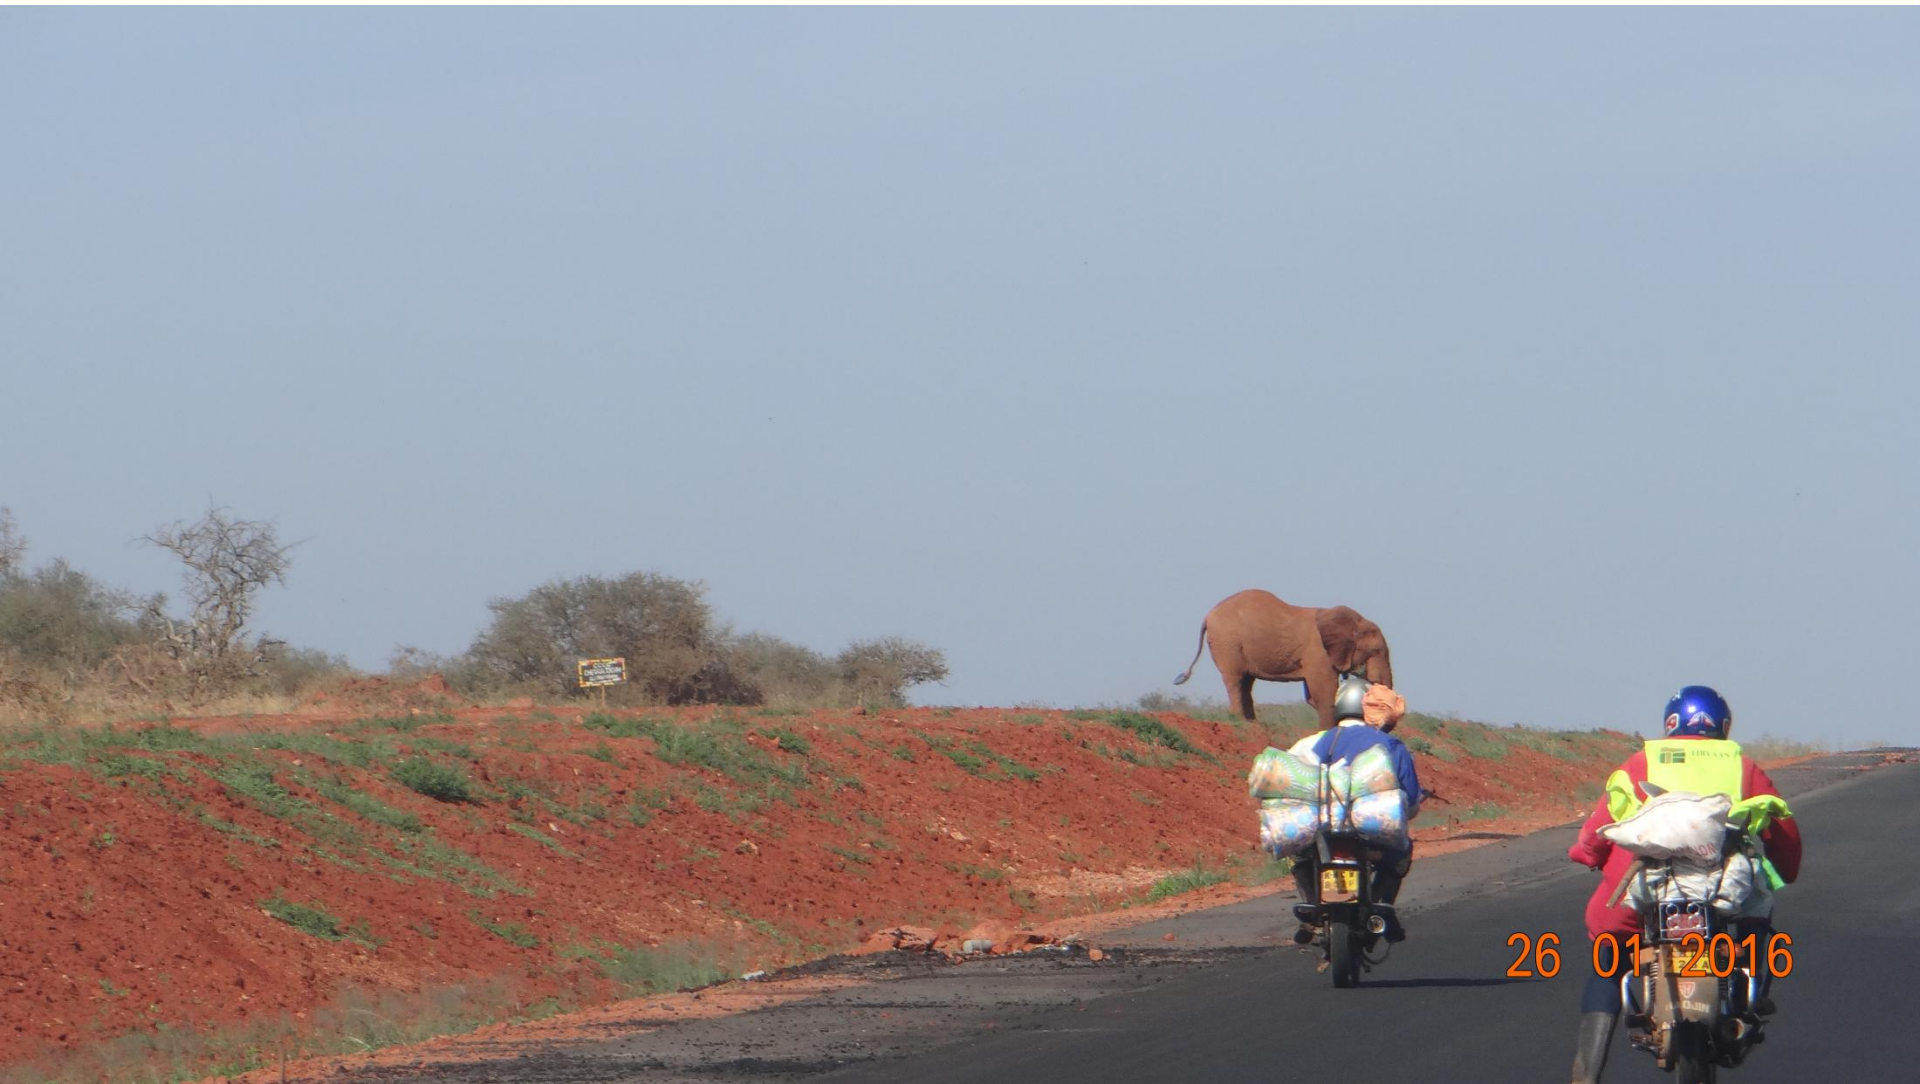
Wildlife crossings on the road in Park

- The negative impact of this development is that the road passes in the middle of Tsavo West National Park from Maktau to Salaita.
- The road have impacted negatively on wildlife crossings.
- Elephants have to cross the road when moving from southern to northern part of Tsavo West National Park.
- Wildlife road kills are expected to increase on this road though mitigation measures have been implemented.

- Speed bumps and rumbles have been erected on all wildlife crossing areas.
- Elephant grids have been erected in Maktau and Salaita to prevent elephants from moving out of the park.
- Signages have been erected on the road to alert motorists when entering the park.
- Signages have been erected on the corridors to alert motorists on speed limits

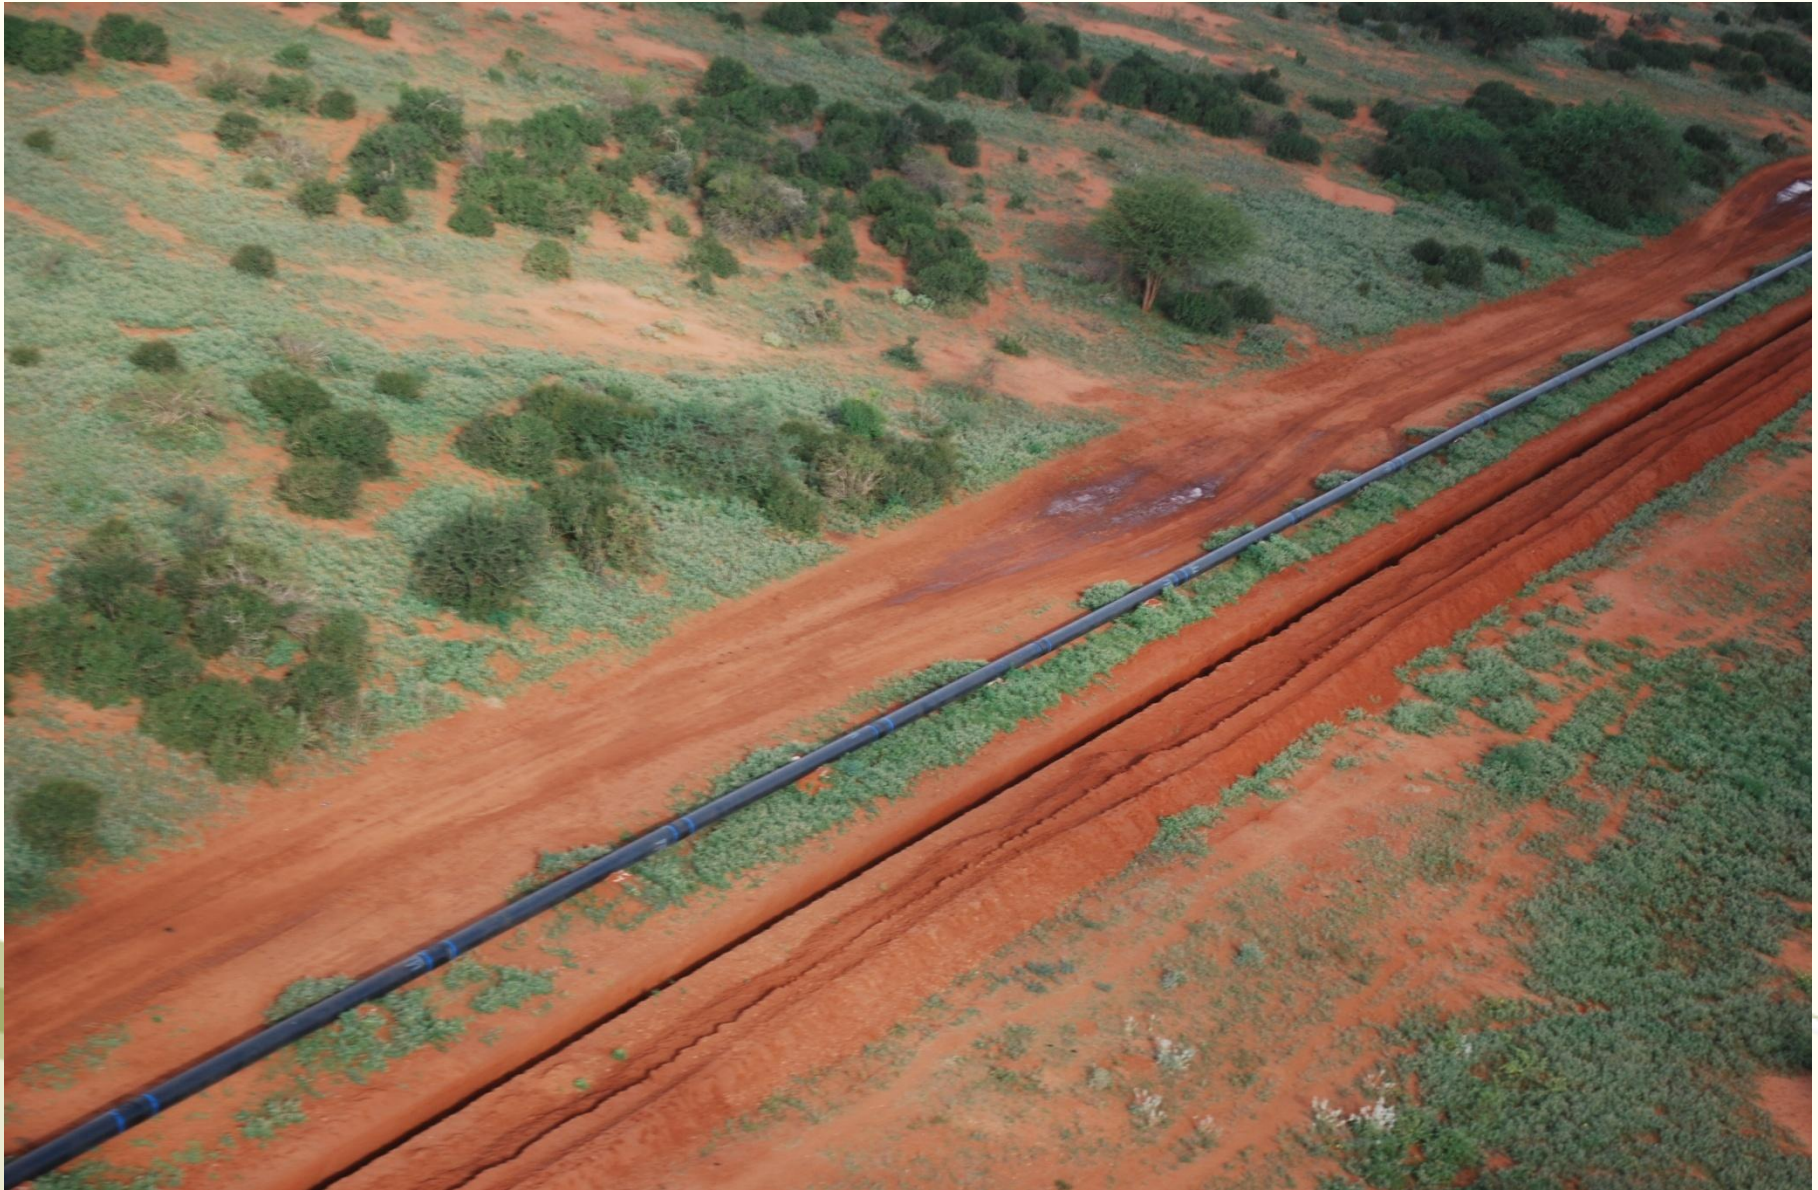
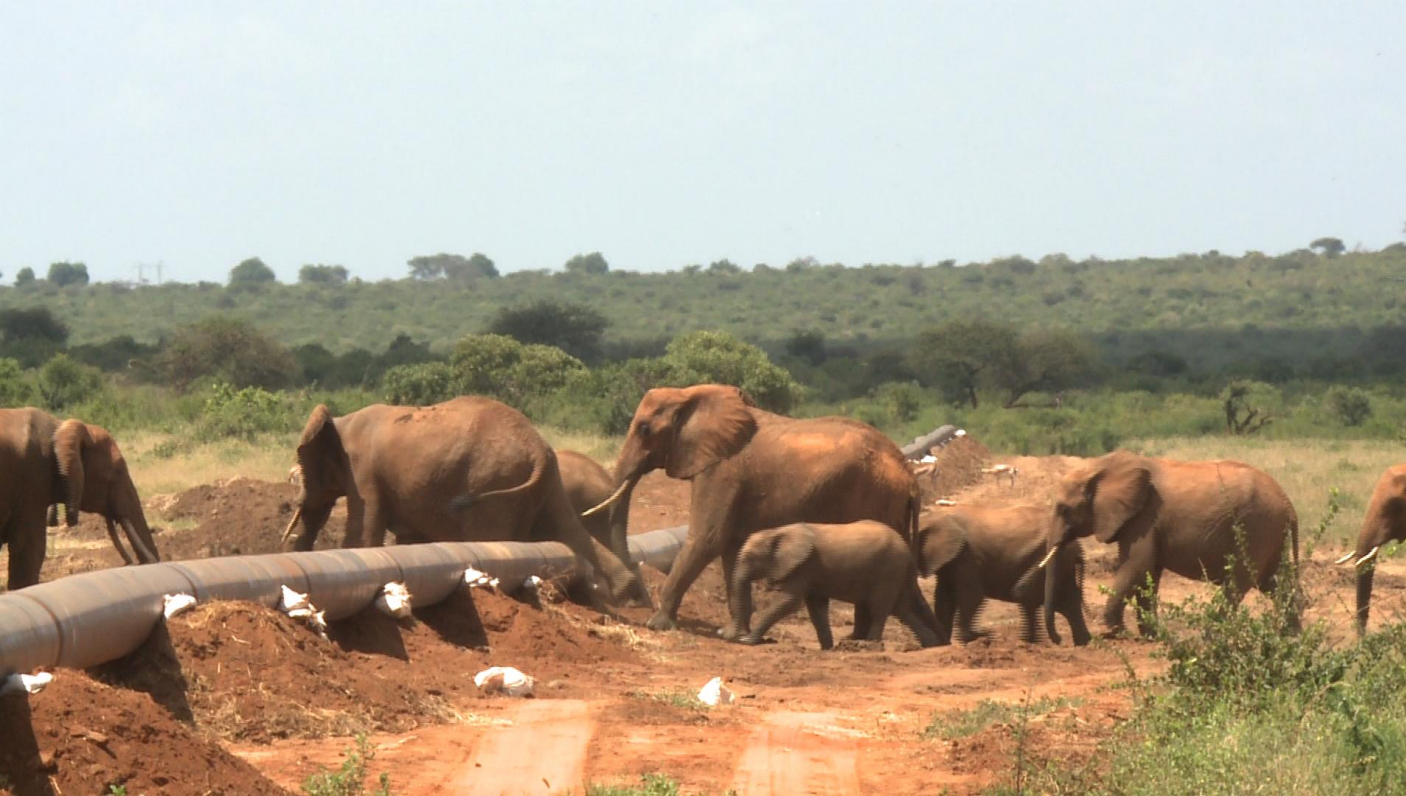
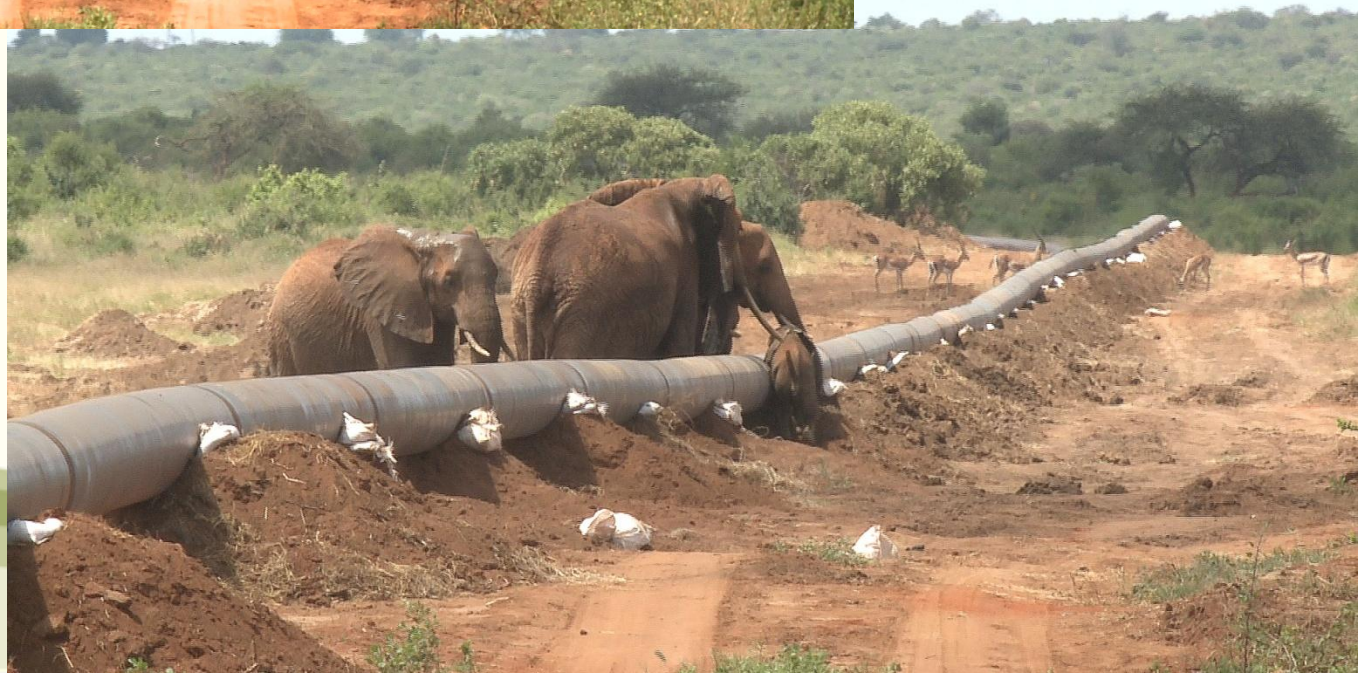
Pipes and the trench left unattended

- Unburied pipes are obstructing wildlife movements.
- In some regions of the park deep trenches dug to bury the pipes are left open making the trenches very dangerous to wildlife.
- Park management has instructed the contractor to connect and bury the pipes as soon as possible.
